NBSIR 73-263

Fire Endurance Tests of Unprotected Wood-Floor Constructions for Single-Family Residences

July 1973

Final Report

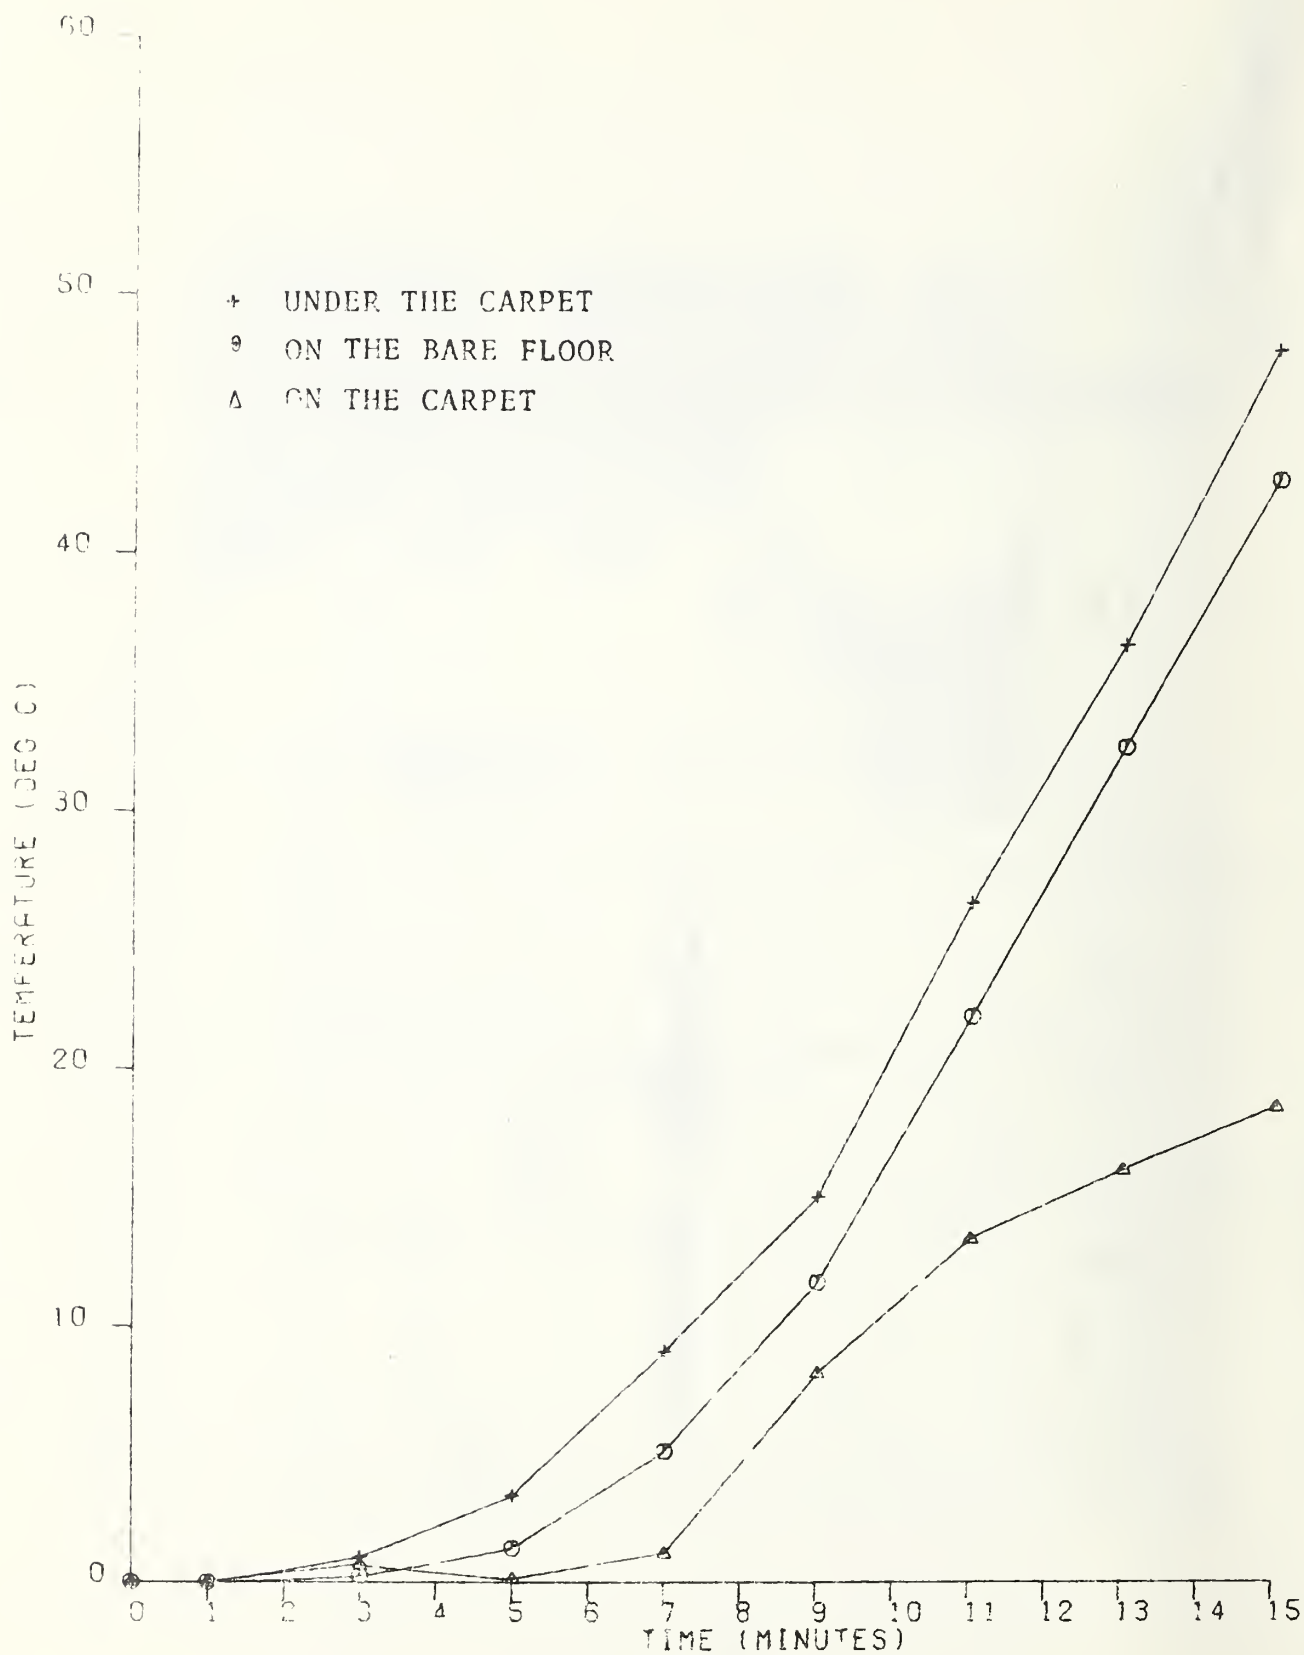
FIGURE 11. Average Surface Temperature Rises on Bare Plywood Floor, Under the Carpet, and on the Carpet (Test #L-1)

The average temperature rise of the surface thermocouples on the "bare" floor was less than 75°C when the test was terminated after 15 minutes. A single thermocouple on the carpet exceeded a 50°C rise, with a reading of 80°C indicating that it may have been directly over a nailhead. The average temperatures of the "bare" floor and the carpet-finished floor are shown along with the average temperature beneath the carpet in figure 11.

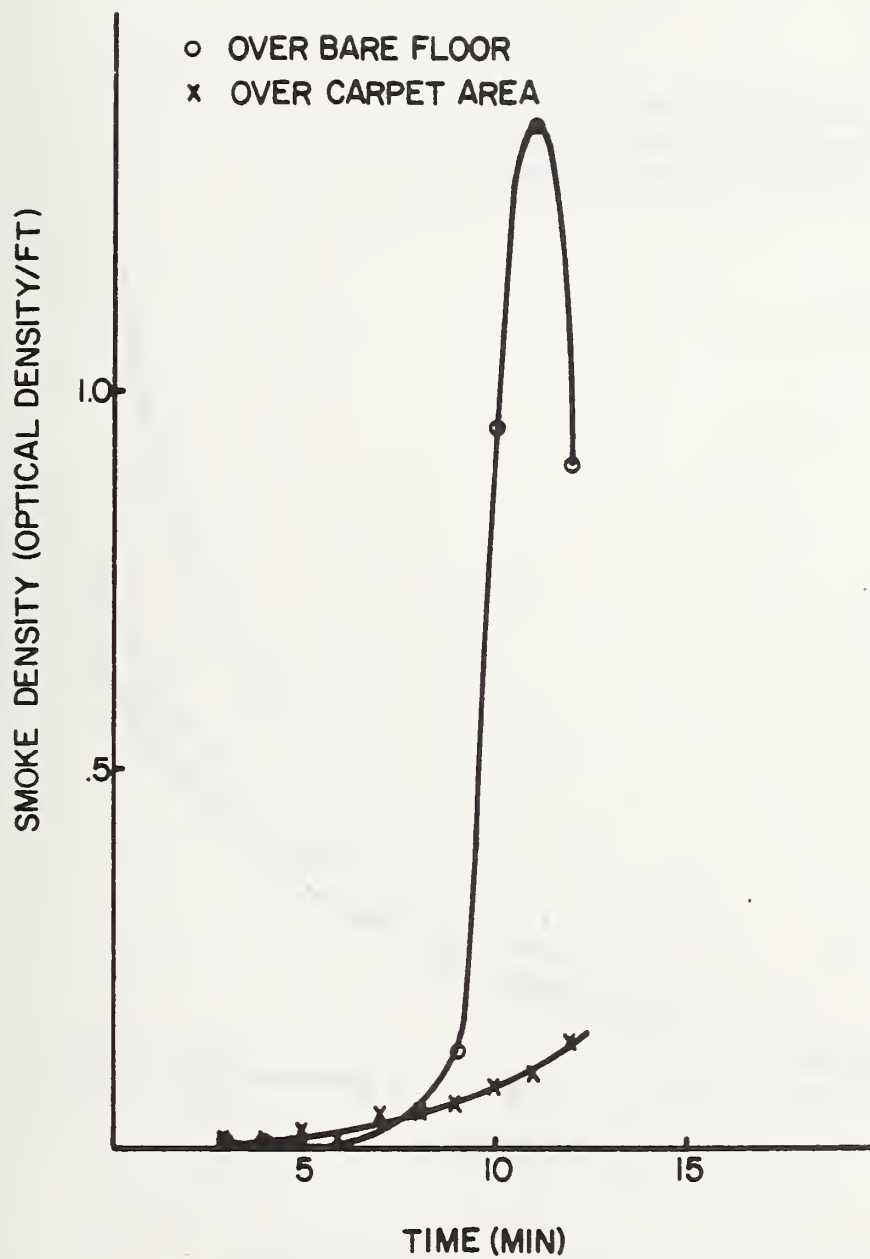
FIGURE 12. Smoke Density, Test #L-1

The smoke meter on the "bare" floor showed a sudden increase in smoke at about 9 minutes, which was more than 4 minutes before "flame through" was noticed. The smoke level indicated by the meter over the carpet-finished floor was considerably less. Smoke meter transmission is given in Table 2, Appendix I and figure 12.

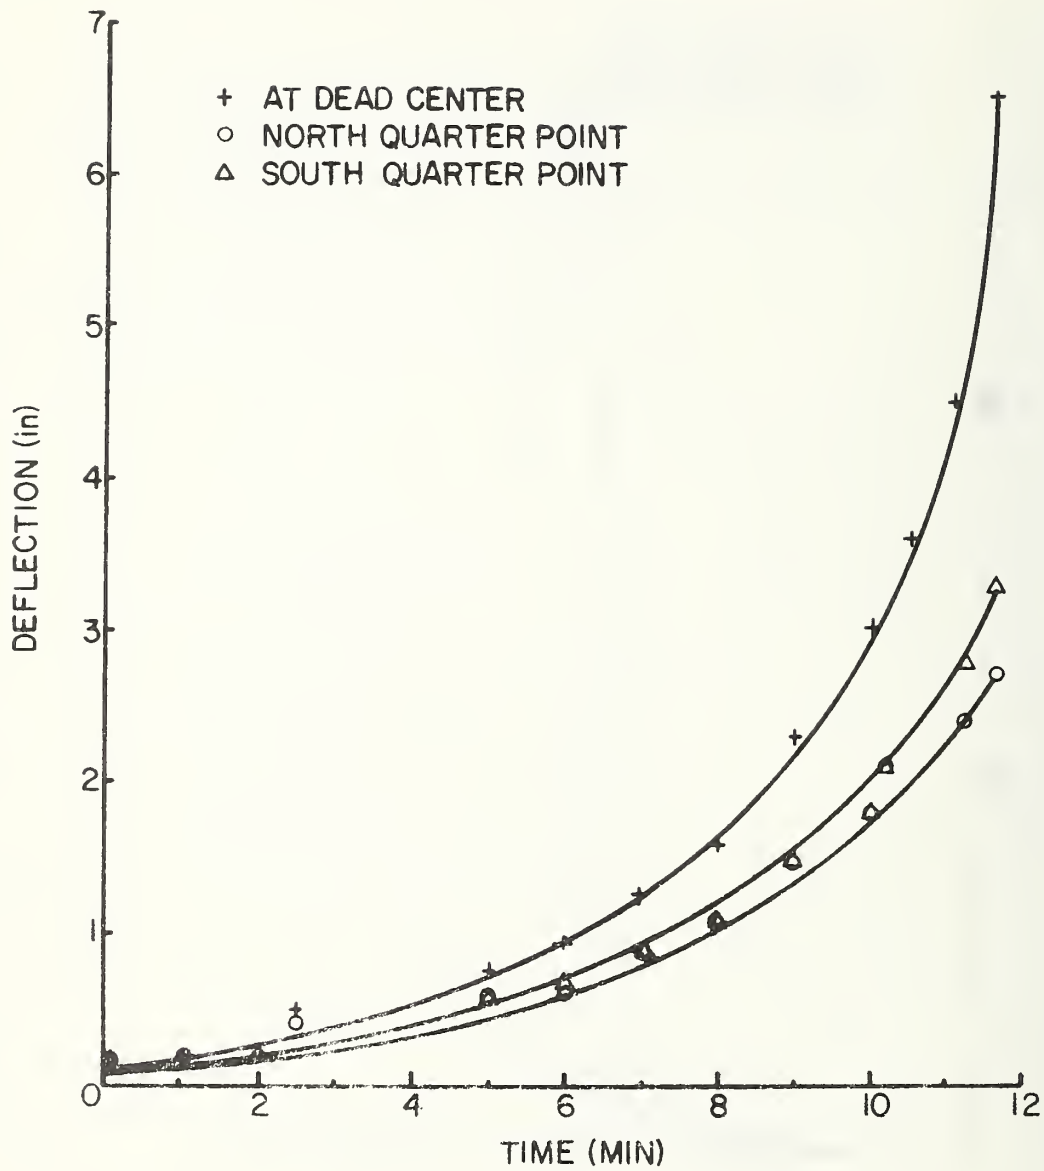
FIGURE 13. Deflection Measurements Test #L-1

The deflection increased steadily to 6.5 in. at 11 min:38 sec when the load could not be maintained as shown in figure 13. Deflections are tabulated in Table 3, Appendix I.

In the small scale tests (#S-4, -6 and -8), it was obvious that the carpeting delayed the time of "flame through" and temperature failure by 8 to 12 minutes. In the large scale test (Test #L-1), the carpet itself did not add any strength to the floor as evidenced by the slight difference in the deflections between the floor sections with or without carpet (see figure 13).

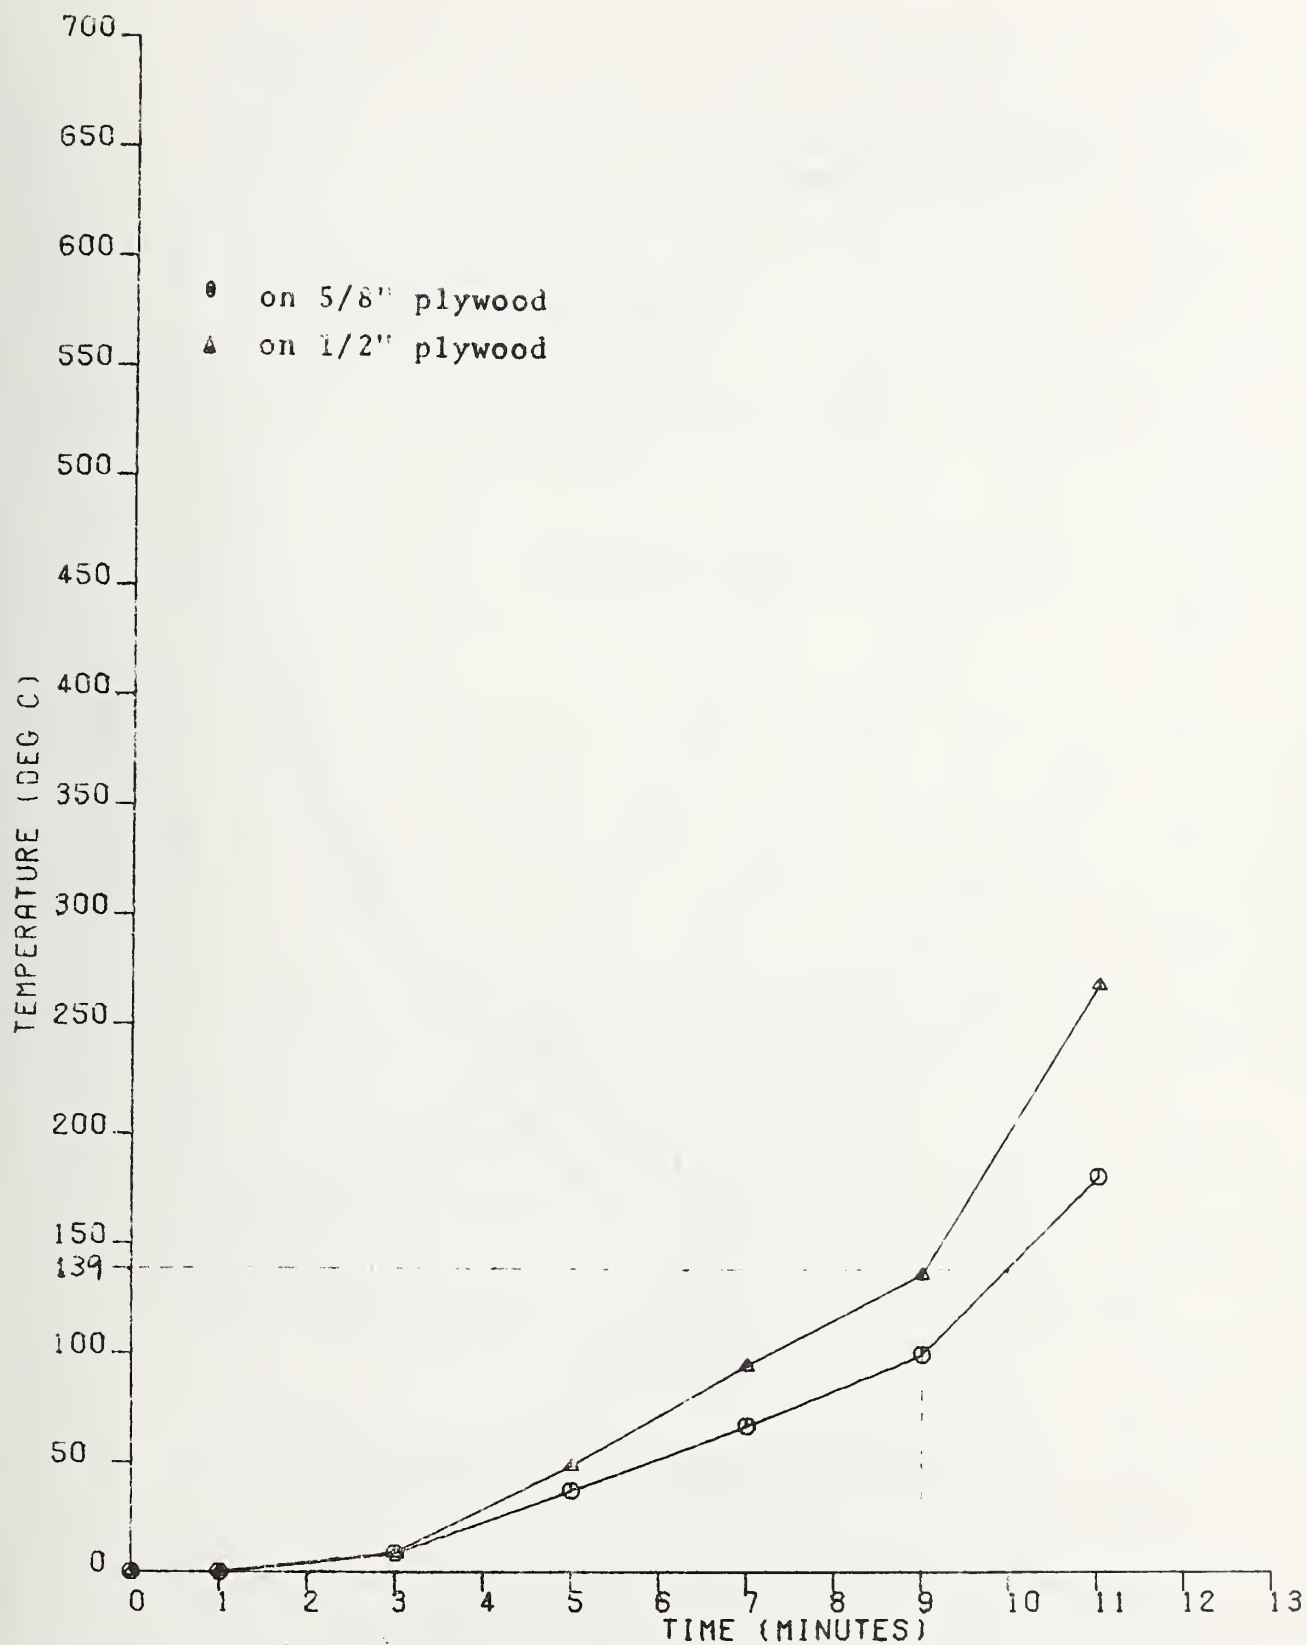
FIGURE 14. Average Temperature Rises for Test #L-2

Figure 14 illustrates average temperature rises on the unexposed surface. Temperature failure occurred at 9 min. for the 1/2 in. plywood floor and 10 min. for the 5/8 in. plywood floor.

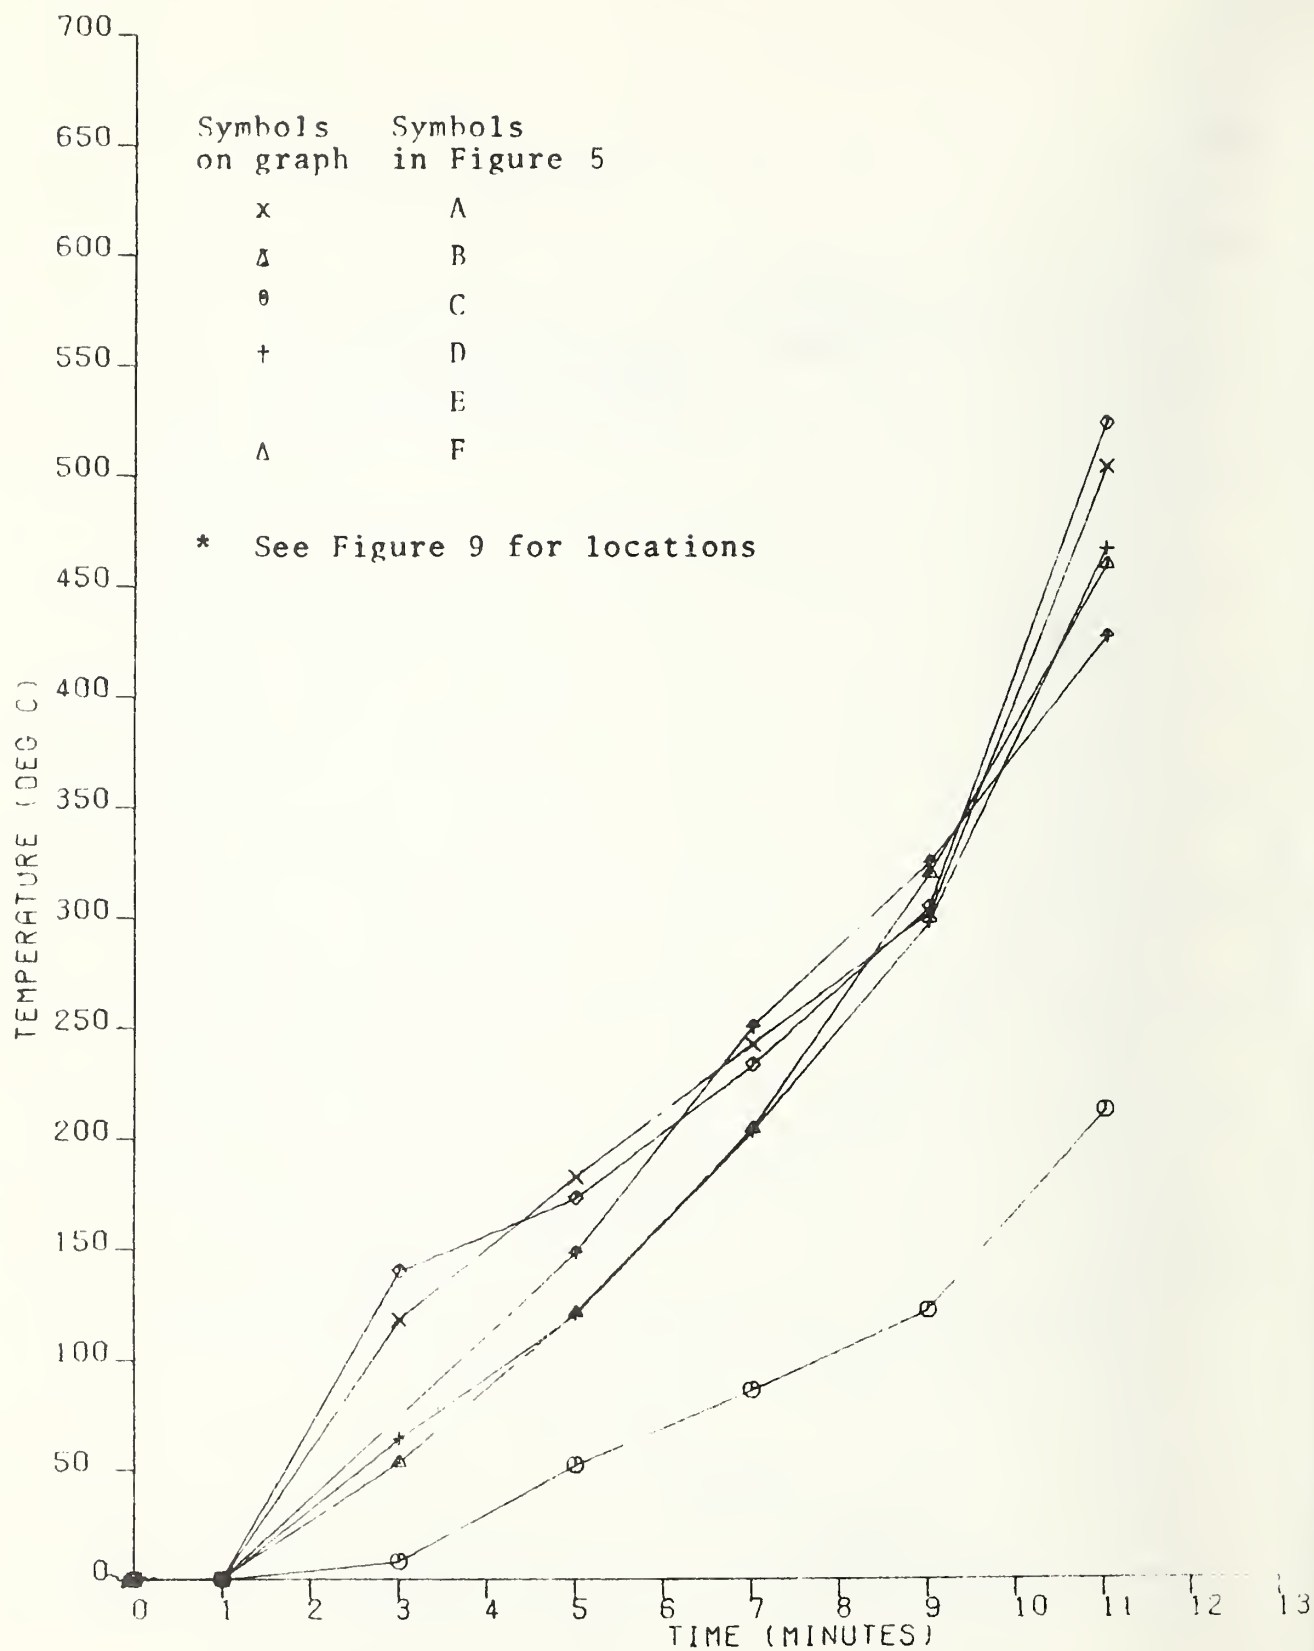
FIGURE 15. Temperature Rises of Special Thermocouples For Test #L-2

Figure 15 is the temperature history of six specially arranged thermocouples (see figure 5). The slow rise in temperature of thermocouple C illustrates the effectiveness of the blocking in protecting the joint.

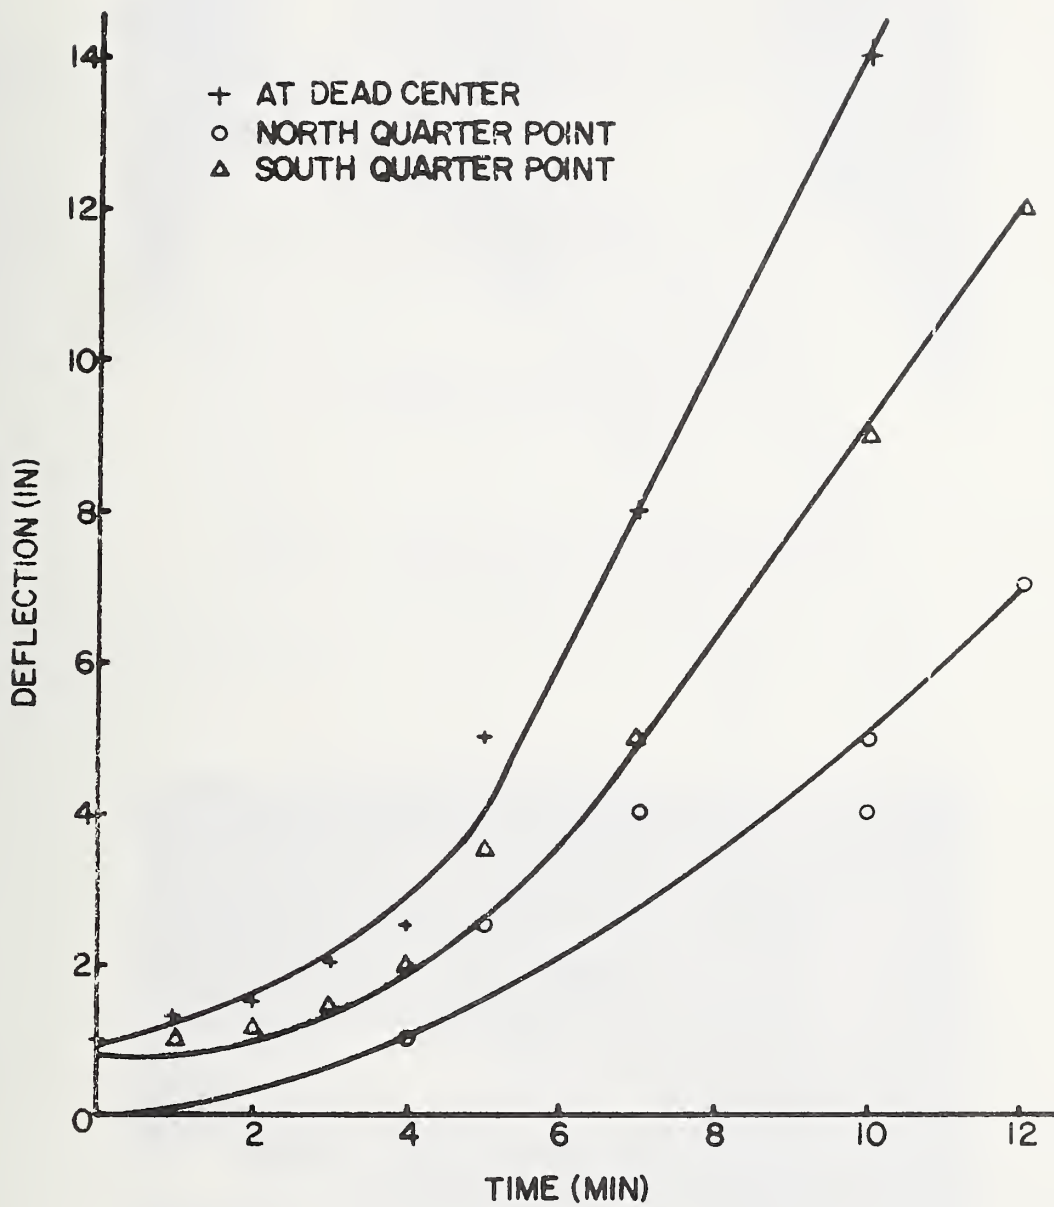
FIGURE 16. Deflection Measurements, Test #L-2

The deflections are tabulated in Table 4, Appendix I and shown graphically in figure 16. The deflection increased rapidly and the floor broke through at 13 min.

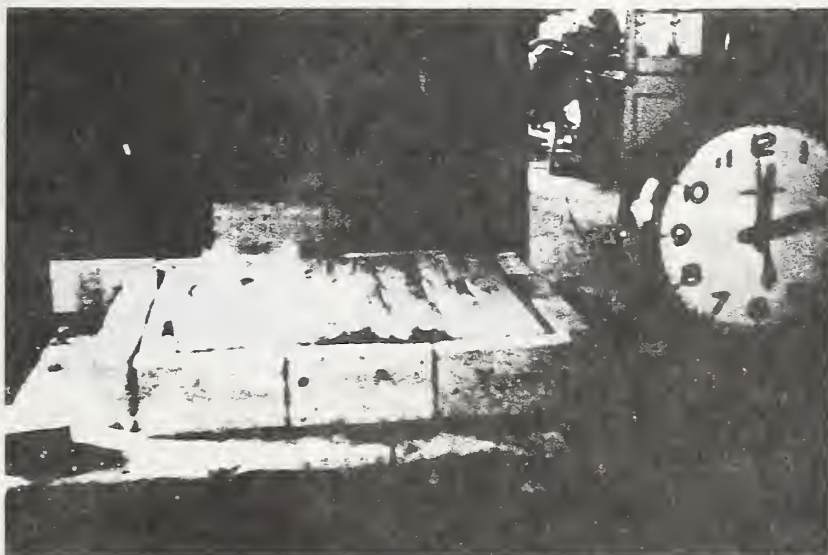
Fig. 19. Locations of Flame Through
Openings at Joint (after
removing load) Test #S-5

1:00	Joist started to burn.
6:00	Exposed surface under thick flame.
9:00	Smoke was noticed around T and G joint near the north end. At the same time its color became charcoal black, and sagging and opening at this joint was observed.
9:30	The fire inside furnace was seen through the opening.
10:30	"Flame through at the joints. The locations of "flame through" and openings at joints are seen in Figure 19.

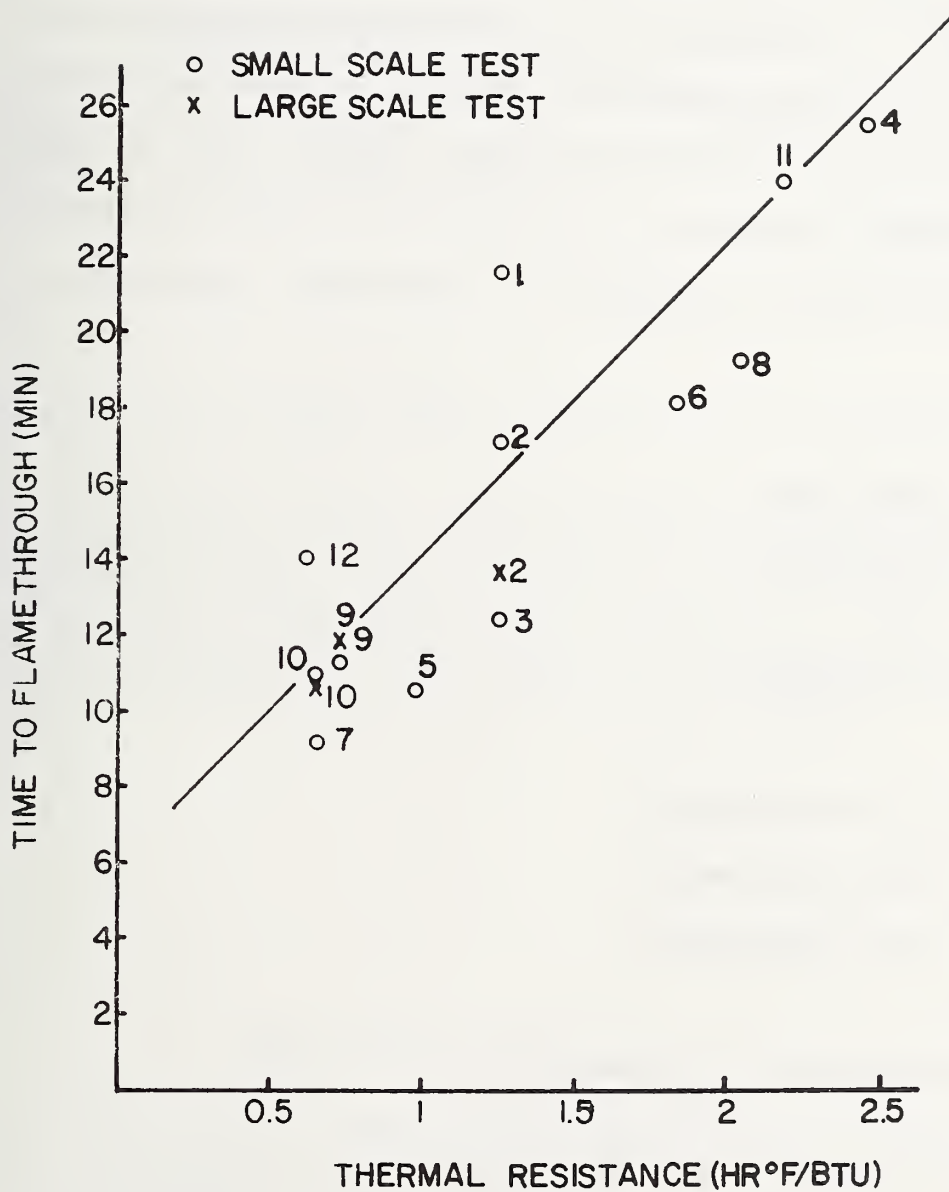
Fig 28 Thermal RESISTANCE of Floor Construction Vs Flamethrough Time

Figure 28 illustrates the influence of the thermal conductivity of various materials on the time of "flame through" under free convection conditions and at room temperature. It is apparent that construction #S-4 (1/2 in. plywood + 1/2 in. plywood + 1/8 in. gap + carpet) has the largest value of thermal resistance and requires the longest time for the flame to penetrate through the floor. It can be also seen in figure 28, that empirically there is a linear relation between the thermal resistance and the "flame through" time. The developed slope K is 0.133 (BTU/°F).

For instance, a 1/8 in. vinyl asbestos tile will add a thermal resistance (R) of 0.05 (HR °F/BTU) to the floor. The additional time for the flame to pass through the tile with a resistance of $R = 0.05$ (HR °F/BTU) will be 24 seconds. The flame through time of 11 minutes was observed by experiment on 1/2 in. plywood with 2 x 3 blocking (test #L-2 and #S-10). Thus, the total time required for "flame through" on the floor construction of 1/2 in. plywood with 2 x 3 blocking, finished with 1/8 in. vinyl asbestos tile can be estimated as 11 min:24 sec.
